REPORT NO. 79

MALFUNCTIONING OF G-15 BOMB BACK AND B-7 SHACKLE

LTC H. H. Zornig

**July 1937**

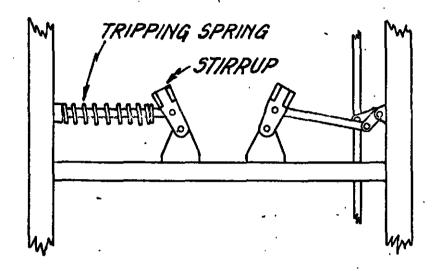
FIG. 1

11. Measurements were next made to determine the force which will be exerted by the stirrup (Fig. 1) of the bomb rack on the trigger of the shackle when the rack is tripped. These measurements were made with a spring balance and a hook in the nammer shown in figure 8. Measurements were made on all the stations of the bomb racks (G-15) in the B-10 Airplane No. 33141 and are given in table II.

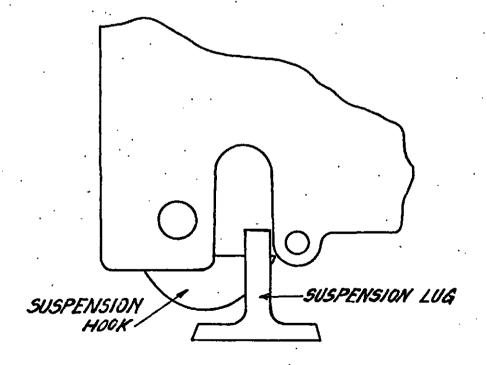
F1G. 6

8. Experiments were then undertaken to lear something about the amount of force which is required to operate the trigger of the B-7 shackle under various conditions. In these experiments the shackle was attached to the hook of a small hoist as shown in Figure 3. A 1100 lb. Demolition Bomb Mk III without fuze or fin assembly (wt. 1073 lbs.) was attached to the shackle in the normal way and lifted a few inches from the floor. The force required to move the trigger to release the bomb was measured by a spring balance in the manner shown in Fig. 4. The force required to pull the trigger of a number of different shackles under a variety of conditions as indicated in Table 1 was then measured. The values of the forces given in the column headed "front" are those obtained when the suspension lugs of the bomb were as near to the pivots of the suspension hooks as the slots in the shackle will permit (Fig. 5) while the values given in the column headed "rear" are those obtained when the suspension lugs were as far away from the pivots of the suspension hooks as the slots in the shackle will permit (Fig. 6).

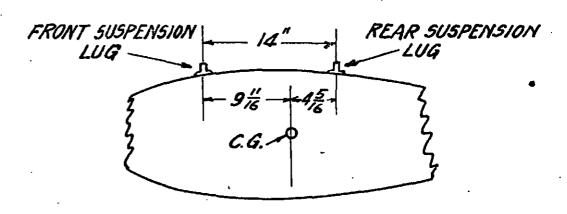
9. The 1100 lb. Demolition Bomb Mk III hands in the bomb rack in the manner shown in figure 7. The total weight of the bomb complete is approximately 1132 lbs. and total pull on the two hooks of the shackle under these conditions is approximately 1832 lbs. As the force required to more the trigger is produced almost entirely by the friction between the cam surface of the trigger and the sear and as the pressure of the sear on the cam surface of the trigger is proportional to the total pull on the two

LOAD ON SHACKLE WHEN CARRYING 1100 LB.
DEM. BOMB MK. III.

FRONT HOOK 564 LB5.

REAR HOOK 1268 LB5.

TOTAL 1832 LB5.
